Citation: Göker, P., & Erdoğan, E. (2018). The Restitution and Design Principles of Beylerbeyi Palace Gardens, Istanbul. *Journal of History Culture and Art Research*, 7(3), 60-78. doi:<http://dx.doi.org/10.7596/taksad.v7i3.1465>

The Restitution and Design Principles of Beylerbeyi Palace Gardens, Istanbul

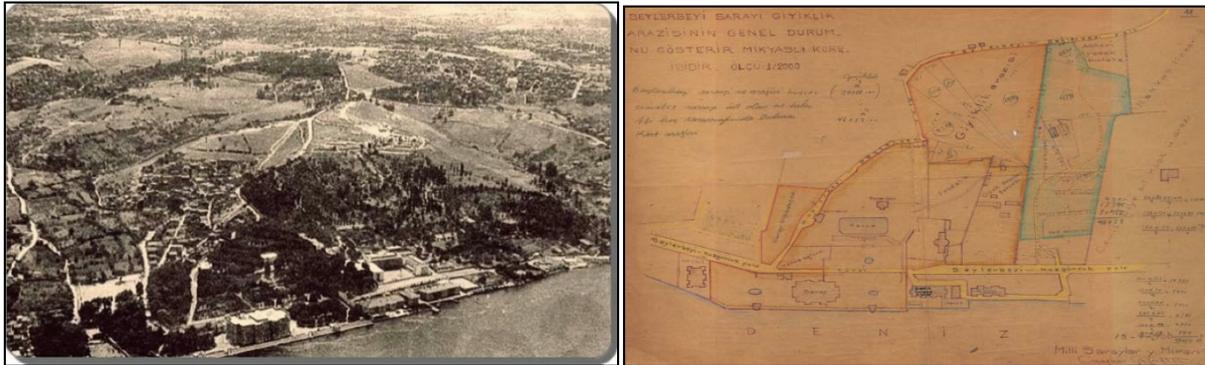
Figure 1. New Beylerbeyi Palace Gardens (Aliasghari Khabbazi, 2016)

Figure 2. Settlement plan of the new Beylerbeyi Palace Gardens (Atalay Seçen, 2011)

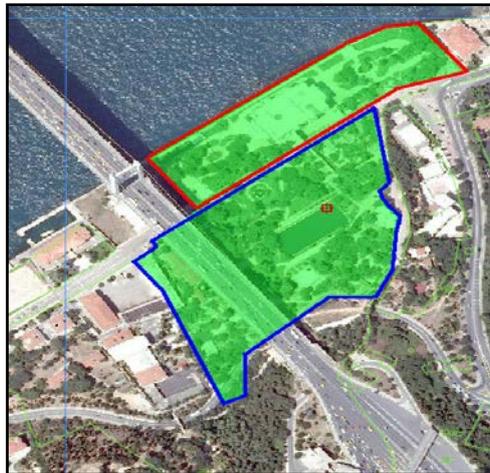
Figure 3. Beylerbeyi Palace Land "Uskudar, 1133 islands, 14 parcels-red border; 1333 island, 47 parcel-Blue border " (Kuzucuoğlu, 2011)

22.016 m2 of the area where the main building of Beylerbeyi Palace gardens is located at Uskudar district, 122 plot, 1333 block, 14 parcel and the terrace gardens of 40.869 m2 including Mermer, Sari and Ahir mansions are located in 1333 block, 47 parcels as registered in the name of Treasury of Finance. All structures of Beylerbeyi Palace Gardens are positioned independently and in an unsymmetrical manner in the land. The main structure of the palace is located on the shore while the other buildings are built in terraces gardens according to their functions. Beylerbeyi Palace gardens have a different set up in terms of their general design features in comparison to other palace gardens in terms of their coastal mansions and gardens or terrace gardens. The gardens between the palace mass (main building) and the sea are designed in a more formal way and having more general use; the terraces gardens located on the upper level are designed for more special uses. Some of the terrace gardens have geometric partitions; while the terraces on the higher side are more informal (Aliasghari Khabbazi, 2016). The main building of the Beylerbeyi Palace Gardens, built as a summer palace, was used for management, living, hosting and representation of foreign guests; Sari mansion, Serdab mansion and Deniz mansions were used for resting purposes; and Ahir mansion was built for palace horses and caretakers. I. Abdulhamid Primary School, I. Abdulhamid Imaret Kitchen, Barracks, and Wreaths, Kalfalar Building and Kizlaragasi buildings do not exist today.

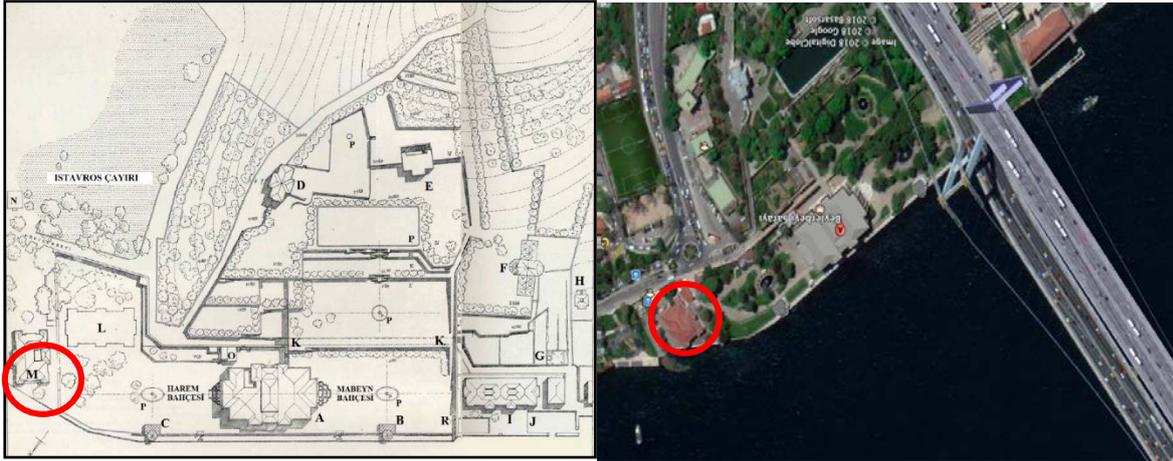
Figure 4. Kızağalar Bulding (M) was located in the southern part of the Harem garden in Beylerbeyi Palace land, (Aliasghari Khabbazi, 2016)

Figure 5. It is showing that structure was left out of the harem garden (Earth Pro, 2018)

Restitution of Beylerbeyi Palace Gardens and Their Vicinity: The structure located in the southern part of the Harem garden in Beylerbeyi Palace land and remaining outside of the Harem wall is called Kızagalar section. This structure was built during the erection period of New Beylerbeyi Palace Gardens. Today, this building functions as Beylerbeyi Sabancı Advanced Technical School for Girls. In 1906, repair works were carried out in the vicinity of Beylerbeyi Palace. In this study, “Kapi Aglari” section, “Mesaib Aglari” section and “Haznedar Aga” section situated in the Harem building were renovated. Moreover, the water reservoir and water channels of the palace and the pathway going from “Kızagalar” section to “Bostancibasi Abdullahaga Mosque” were renovated. In 1922, the road leading to “Bostancibasi Abdullahaga Mosque” from the “public bath” building, which does not exist today, in Harem garden was renewed. The Bosphorus Bridge, built in 1973, is located in Beylerbeyi Palace gardens on the Anatolian side. The feet of the bridge are positioned in the fourth terrace garden. The fact that the bridge passes over the palace land gives damages both to the palace and the gardens visually and physically. “I Abdulhamid Sibyan Mektebi” and “Batltacilar and Hamamcilar” building, which were situated at the rear side of Selamlık garden wall of Beylerbeyi Palace and constructed in 1863 during the construction period of the New Beylerbeyi Palace Gardens and belonging to the palace complex, were demolished for the bridge construction. Only the Boat Port survived until today among the original structures in this area (BOA., HH.EBA. 21/39).

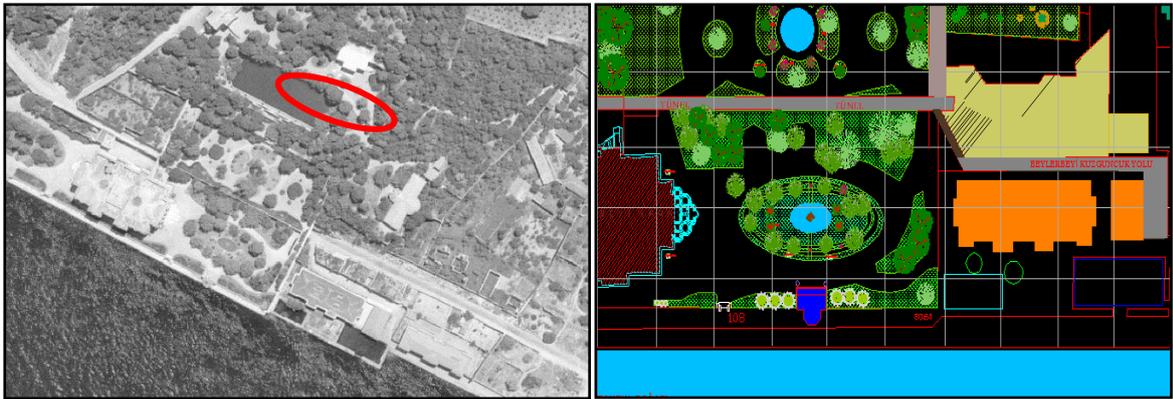
Figure 6. Buildings destroyed during the construction of the Bosphorus Bridge (Original 2016)

Figure 7. Beylerbeyi Palace’s aerial photograph taken in 1960 (Aliasghari Khabbazi 2016)

When the aerial photograph of 1960 obtained from the General Command of Mapping is evaluated, it is determined that there are the tall wall in front of the Harem garden on the land side has a dense green texture and there are tall trees. It is understood that the trees in this area are *Tilia agrentea* and *Quercus robur*. Today, there is a cafeteria and gift shop in this area. The size of this area is about 1,500 m² consisting of grass parterres. Within these parterres, pedestrian pathways were created with the aim of providing access to the cafes and gift shop. Concrete was used as flooring material in these roads. In these parterres, there are *Robinia pseudoacacia*, *Nerium oleander*, *Fraxinus angustifolia*, *Hibiscus syriacus*, *Buxus*, *Taxus baccata*, *Phoenix dactylifera*, *Cedrus deodora* and *Araucaria araucana*. In the photo taken in 1900s, the pool and the circular shaped plant parterres around it are remarkable. Symmetry was applied in the plantation arrangement and the general design of the parterres. The roundness of the lines of the parterres softens the lines of the garden. *Tilia sp.* and *Cedrus* were used as plant materials. There are circular-shaped parterres at the corners of the parterres that are arranged in four parts, and there are *Rosa sp.* situated in the middle of these parterres.

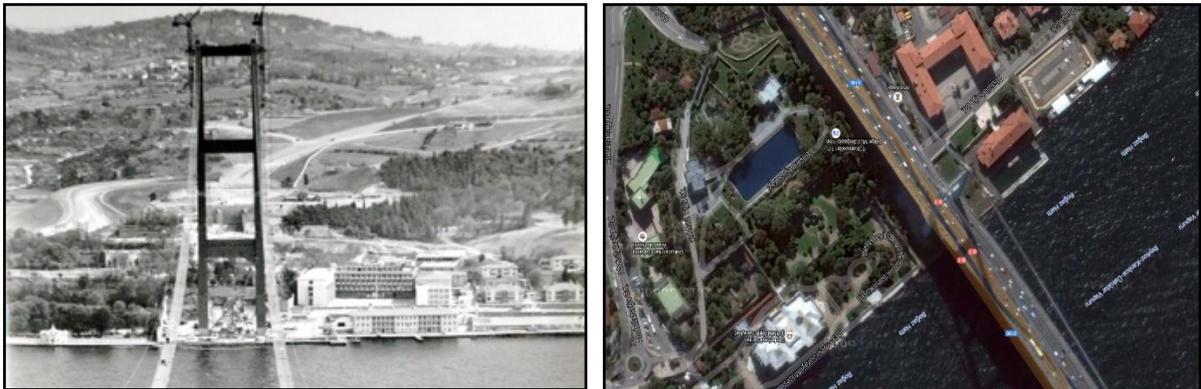
Figure 8. Construction of Bosphorus Bridge, Istanbul, Anatolian Side (Topçu, 2006)

Figure 9. The Boat Port that reached today from the construction period of Beylerbeyi Palace (Aliasghari Khabbazi, 2016)

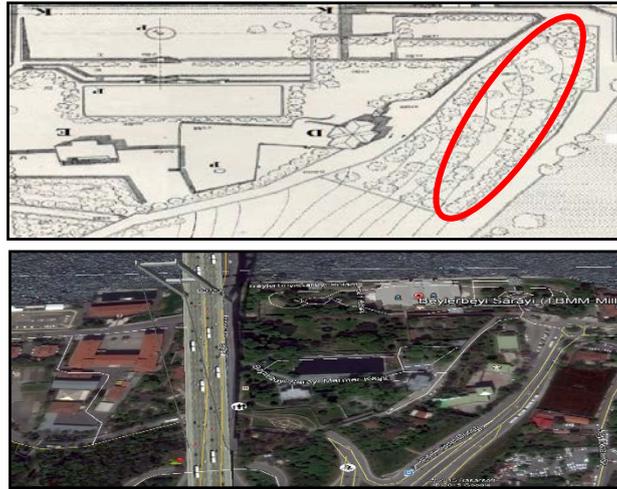
Figure 10. The green area situated between Abdullahaga Avenue and Sahbaz Street in 1900s (Eldem, 1976)

Figure 11. Current status of the green area between Abdullahaga Avenue and Sahbaz Street (Aliasghari Khabbazi 2016).

The southern side of the fourth terrace garden of Beylerbeyi Palace grounds faces Sahbaz Yigit Street, the roadway gate. The area between Abdullahaga Avenue and Sahbaz Street where Beylerbeyi Palace is located is stated as a green area according to maps and photographs taken in 1900's. Today, Turkey Soccer Federation Administrative Building, Turkey Soccer Federation guesthouse, a parking lot and Beylerbeyisi Haci Sabanci High School are located in this area. Based on the data obtained from photographs and maps of 1900s of Beylerbeyi Palace gardens, the green area opposite the Harem garden wall is Istavroz Meadow. Today, this area is divided into two sections with Beybostan Street. There is Beybostan villas in the eastern part, and Beylerbeyi Palace Boutique, a parking lot, Rumeli Bakery and Beylerbeyi Elementary School are situated in the western part. Bostancibasi Abdullahaga Mosque still exists today since its original construction date.

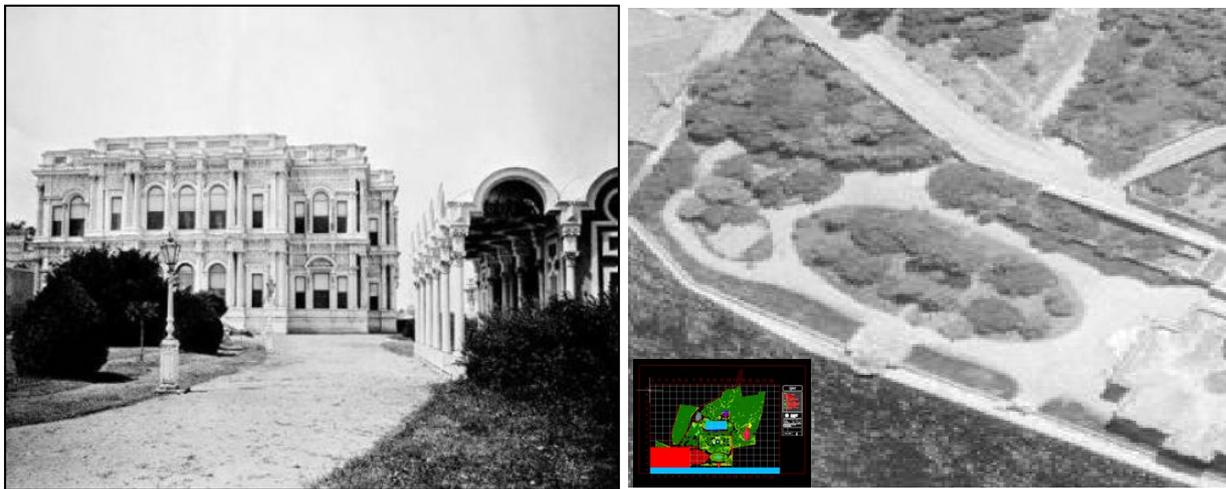
Figure 12. Photo taken by Basille Kargopoulo in 1900 (Atalay Seçen, 2011)

Figure 13. Photo taken by Basille Kargopoulo in 1900 (Aliasghari Khabbazi, 2016)

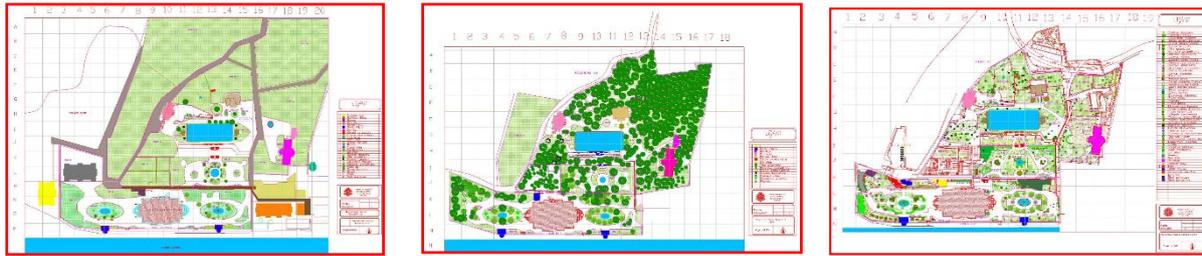
Figure 7. Beylerbeyi Palace Gardens, 1960 dimensioning sheet (Original 2016)

Figure 8. Beylerbeyi Palace Gardens, the dimensioning sheet of the construction period (original 2016)

Figure 9. Beylerbeyi Palace, current settlement plan and dimensioning sheet (Original 2016)

In the assessment of the present state map sheets of Beylerbeyi Palace Gardens, the interim period sheets (1960), and the restitution sheet of its construction period (restitution sheet), it was determined that the area undergone significant changes in general sense in terms of its size and green area ratio (Table 9). In

this context, the palace and the garden and open areas in its immediate vicinity got smaller considerably; this phenomenon has also led to changes in the overall set up and design of the area.
